# LUMMI ISLAND SCENIC ESTATES

LUMMI ISLAND, WASHINGTON

FULL RESERVE STUDY

MAY, 2013

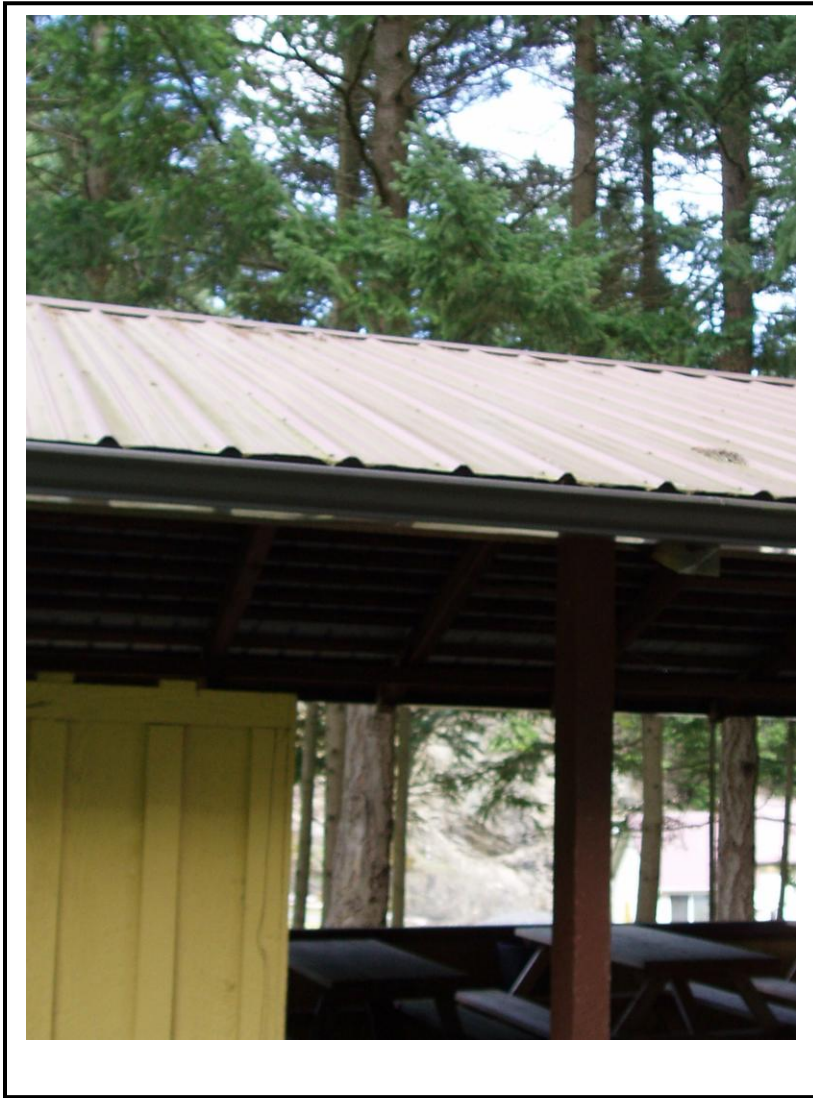
**COMPONENT NAME:** Roofing, Sloped

The roofing of the Association's cabana, maintenance building and offices/treatment plant building is sloped metal. The sloped metal roofing is fairly new and expected to last for over 30 more years without needing to be replaced. The Association intends to make any necessary sloped metal roof repairs with funds from their operating budget.
